WL-TR-91-4140

**LONG-TERM TROPIC ENVIRONMENTAL EXPOSURE  
OF ARMY STANDARD FAMILY (ASF) RIGID WALL  
HONEYCOMB SANDWICH PANELS**

**AUGUST 1992**

**Interim Technical Report Covering the Period October 1983 - November 1988**

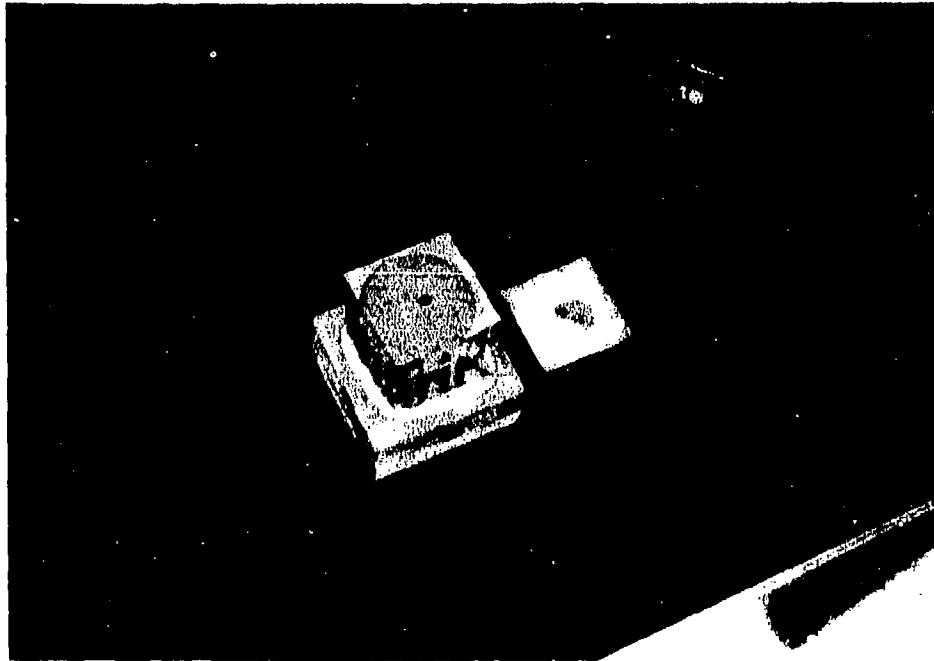
**Figure 40. Repair Patch Flatwise Tension Specimen Failure Mode After 1 Year of Tropical Exposure.**
